UNDERWATER BRIDGE INSPECTION REPORT

STRUCTURE NO. 84505
CSAH NO. 14
OVER THE
OTTER TAIL RIVER
DISTRICT 4 - WILKIN COUNTY

PREPARED FOR THE
MINNESOTA DEPARTMENT OF TRANSPORTATION
BY
COLLINS ENGINEERS, INC.
JOB NO. 5221 (CEI 58)

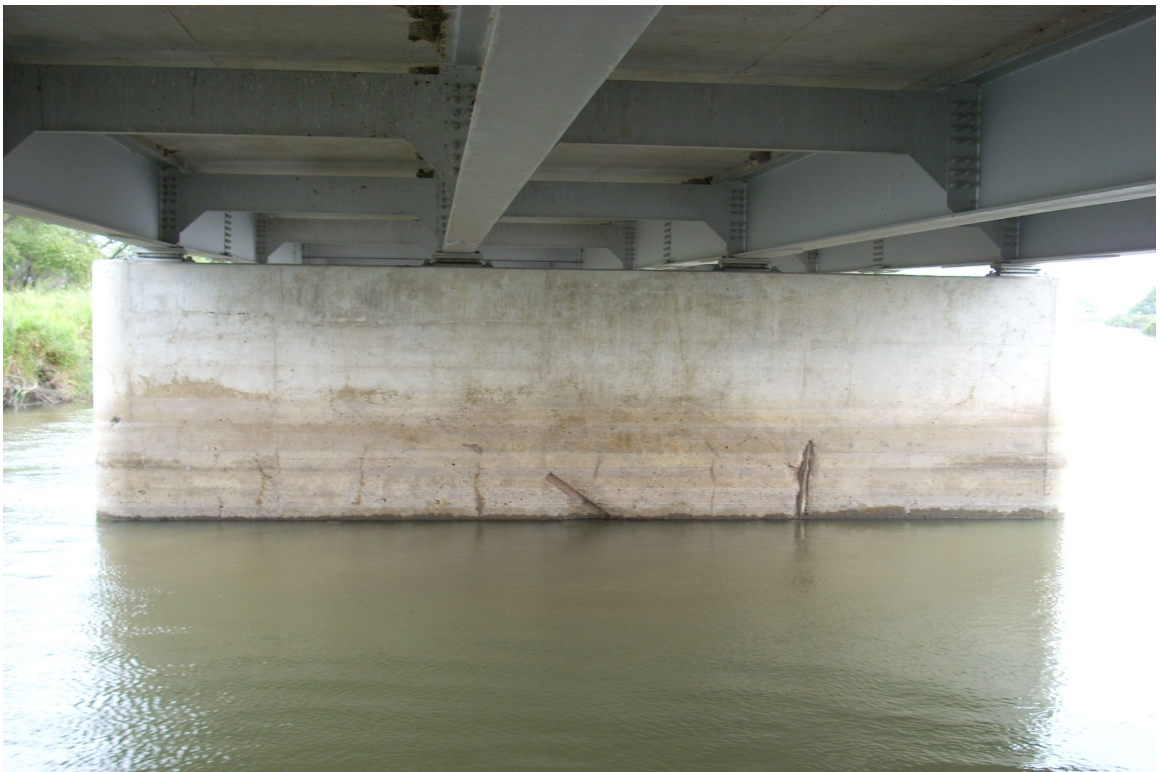
Photograph 2. View of Pier 1, Looking Northeast.

1. The channel bottom consisted of silty sand with up to 12 inches of probe rod penetration.
2. A minor accumulation of branchy timber debris, with pieces up to 3 inches in diameter, along with some minor steel debris was observed on the channel bottom at the upstream end of Pier 1 and extending along the north side of the pier.

4. The concrete pier cap exhibited timber formwork embedded into the south face of Pier 1 with an area of concrete section loss observed along the formwork which was 2.5 feet long, 1 foot wide, and 4 inches deep.

5. A large area of slop concrete was observed on the channel bottom along the center portion of Pier 1.
6. The west embankment was well armored with riprap up to 3 feet in diameter.

8. Scour depression 3 feet radius by 1 foot deep was observed at downstream end of Pier 1.

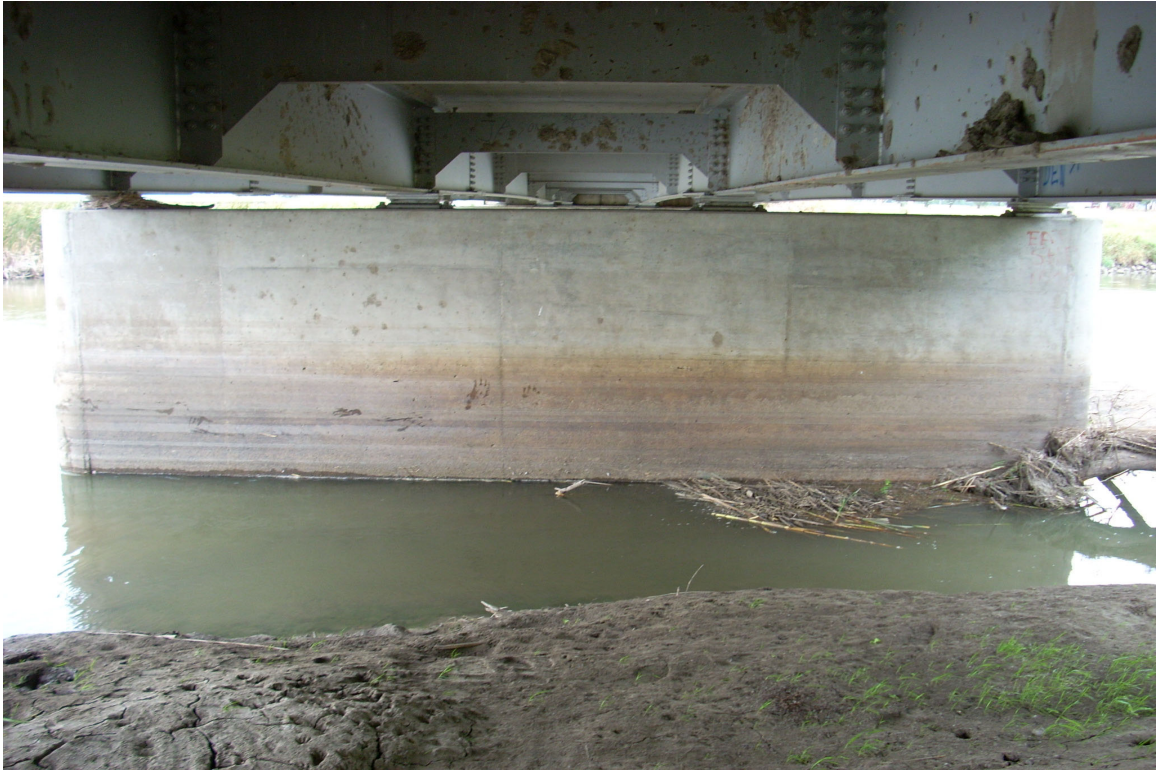
Photograph 3. View of Pier 2, Looking Southwest.

3. Minor accumulations of branchy timber debris were observed all around Pier 2 with a moderate accumulation of larger timber debris, with pieces up to 12 inches in diameter, observed at the downstream end of the pier.

7. Scour depression 3 feet radius by 1 foot deep observed at the upstream end of Pier 2. It extended from upstream end to the downstream 1/4 point on the south side and the midpoint on the north side.
